**EPA Region 10  
PCB Compliance Investigation Report**

**Facility Name:** Oil Re-Refining Company – Goshen Storage & Transfer Facility

**Date of Investigation:** April 9, 2010

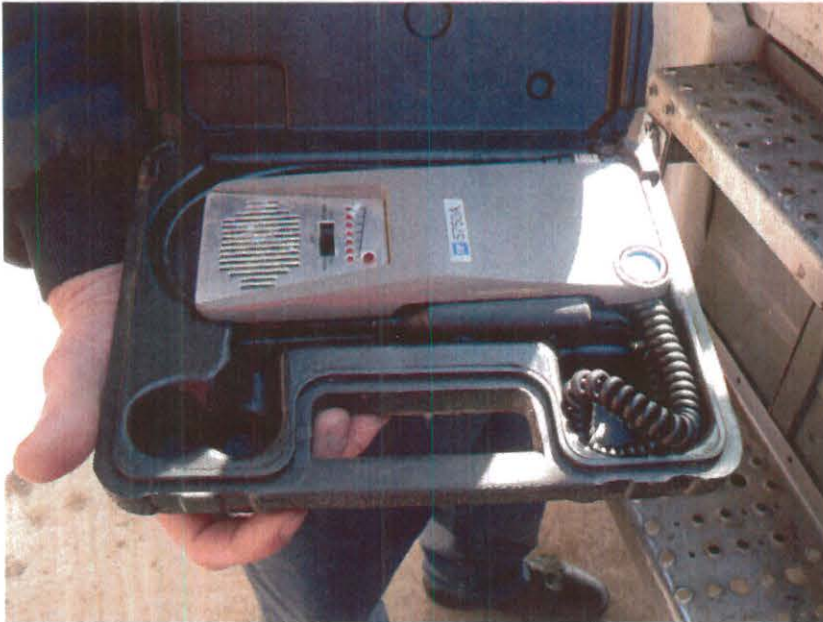
**Photo No:** P1010527

**Description:** This is a TIF 5750A refrigerant leak detector. Mr. Mike Miller stated to me that he uses this detector to measure the concentration of chlorinated solvents in used oil he picks up from customers. He uses this detector in place of using Clor D-test kits.

**Time:** 10:20 am      **Direction:** In the Cab of the ORRCO Truck.

During today's investigation, I learned that the Eugene ORRCO driver had not collected and saved any retain samples for the past three years. In addition, the Eugene ORRCO driver had not used the Clor D-Tect test kits to test the used oils he picked up. Rather, the driver used a halogen detector ORRCO calls a "Sniffer" (Photograph P1010527).

I asked Mr. Miller to show us the sniffer and to show us how he calibrates the sniffer and how he uses it in the field. Mr. Miller showed us a jar of material that looks like oil. On the label of the jar it has "Non-hazardous, Sniff Test Sample 700 – 800 ppm, Going for Recycle" (Photograph P1010528). I asked Mr. Miller and Ms. LeCocq what was in the oil and why this range in concentration. Neither Mr. Miller nor Ms. LeCocq knew what was being tested in the oil. Mr. Miller then demonstrated how he calibrates the sniffer (Photograph P1010529). As he places the wand of the sniffer over the jar, the sniffer alarm does not go off or indicate any reading (the LED lights do not flash). Mr. Miller does not record any information or verify that the battery has a full charge.

The regulations require marketers of used oil to assume that the used oil contains quantifiable levels of PCBs or test that oil to prove no quantifiable PCBs are present. According to Ms. LeCocq and Mr. Miller, the use of this sniffer is to meet the requirements that there are no quantifiable PCBs in the used oil by testing. The sniffer is also being used to quantify the used oil to show it does not contain chlorinated solvents above the RCRA criteria.<sup>4</sup> ORRCO is also having its customers sign and certify a statement that hazardous waste and PCBs are not added to the used oil. Based on this signature and certification, ORRCO is using this information to demonstrate it has "other information" to demonstrate there are no PCBs in the used oil.

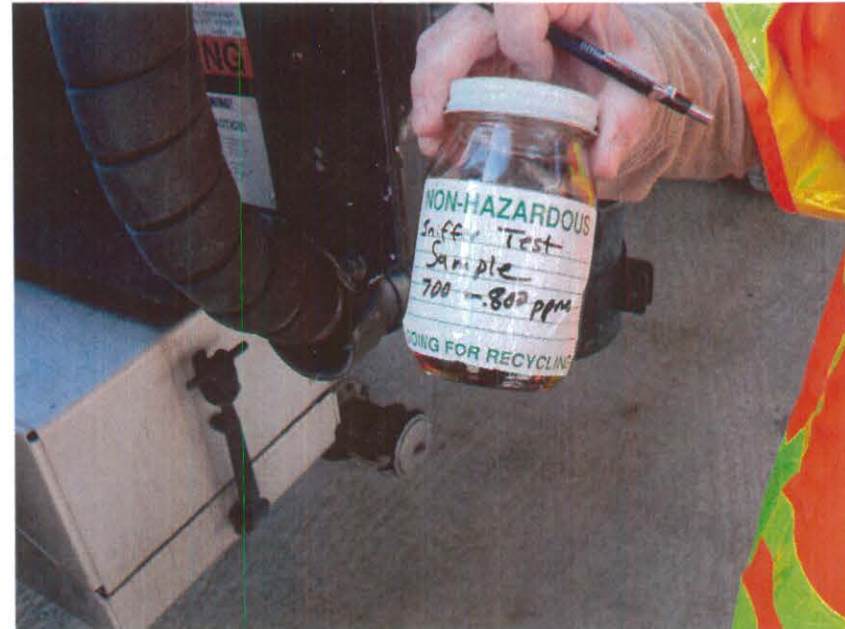
**Photo No:** P1010528

**Description:** Mr. Mike Miller stated that he calibrates his detector using this jar of oil, which contains an unknown chemical at 700 to 800 ppm. Mr. Miller believes it is a mixture of halides in the jar.

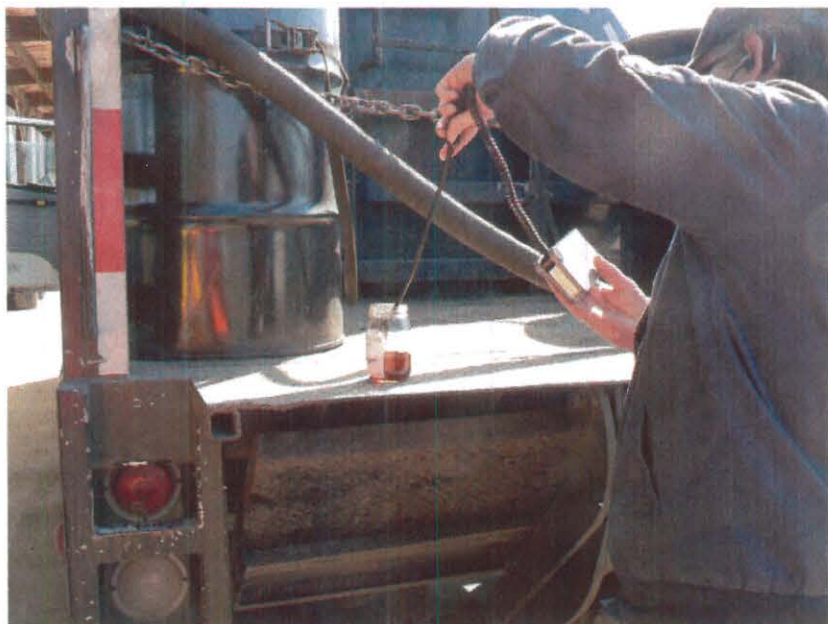
**Photo No:** P1010529

**Description:** Mr. Mike Miller is showing ODEQ and EPA inspectors how he calibrates the Halogen Gas detector. The alarm did not sound when he was testing the oil in the jar with 700 to 800 ppm of unknown halogens. The contents of the jar are not heated during the calibration.

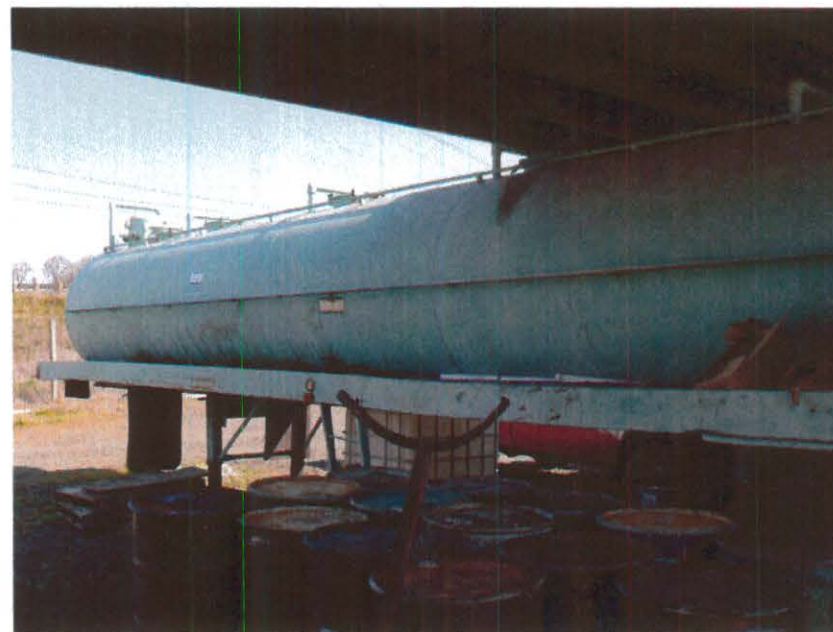
**Photo No:** P1010530

**Description:** This blue-green tank is used to accumulate spent antifreeze. The concentration of PCE in the tank is 100 ppm and PCBs at 1,5 ppm. The 55-gallon containers also contain antifreeze and other liquids. According to ORRCO SPCC Plan, this is a 5,000-gallon tank.

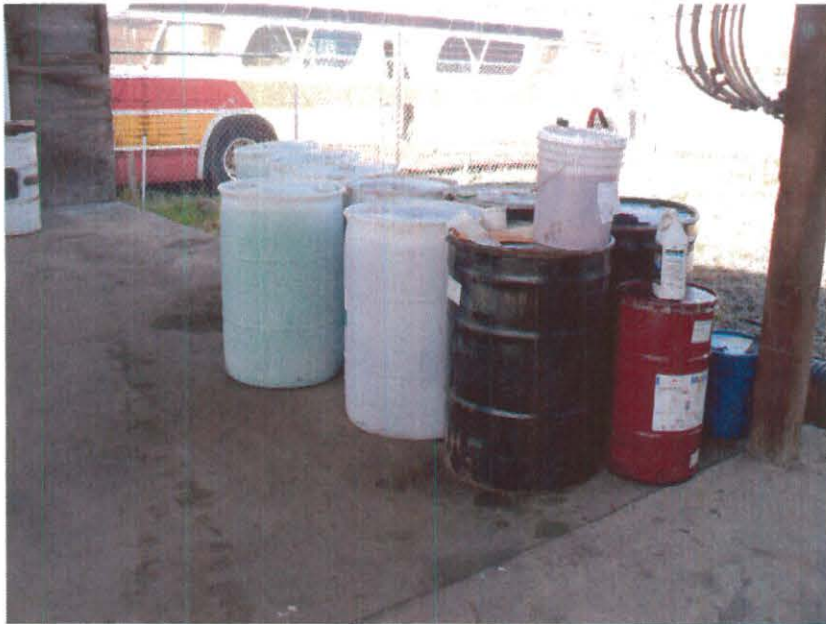
**Photo No:** P1010531

**Description:** These are products sold by ORRCO. The manufacturer is not known.

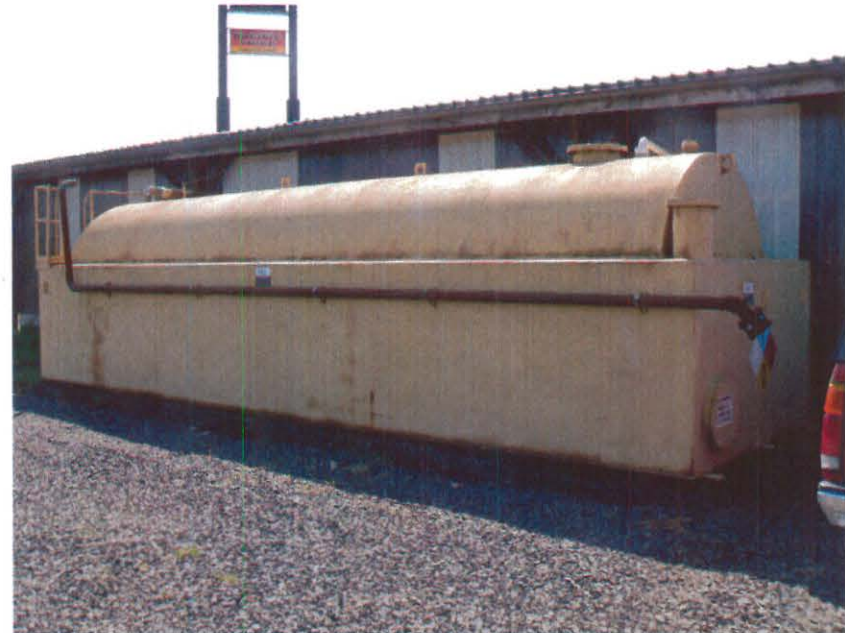
**Photo No:** P1010532

**Description:** This tank is used to accumulate used oils with a high percentage of water. The concentration of PCE in the oil and water is 30 ppm. No PCBs were found in this tank.

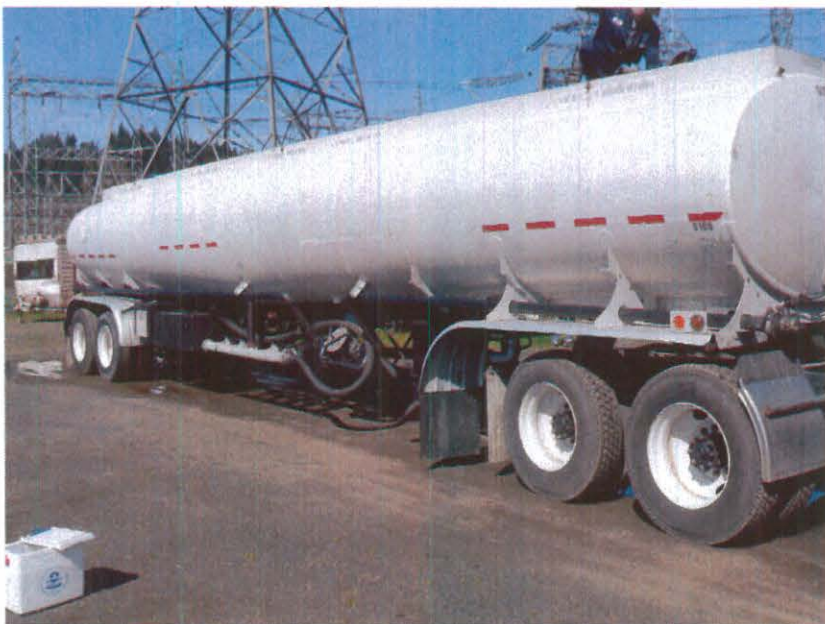
**Photo No:** P1010533

**Description:** Because the tanks at the Goshen facility are full and contain PCBs, the truck and trailer are now being used to accumulate used oils. No PCBs were detected in the EPA samples.
